# Belvidere Theatre

129 Nevada Street  
Central City, Colorado 80427

Historic Structure Assessment and  
Preservation Plan  
SHF Grant No. 2016-HA-005  
Deliverable #5 Final HSA  
July 2016

**HISTORIC STRUCTURE ASSESSMENT  
AND  
PRESERVATION PLAN**

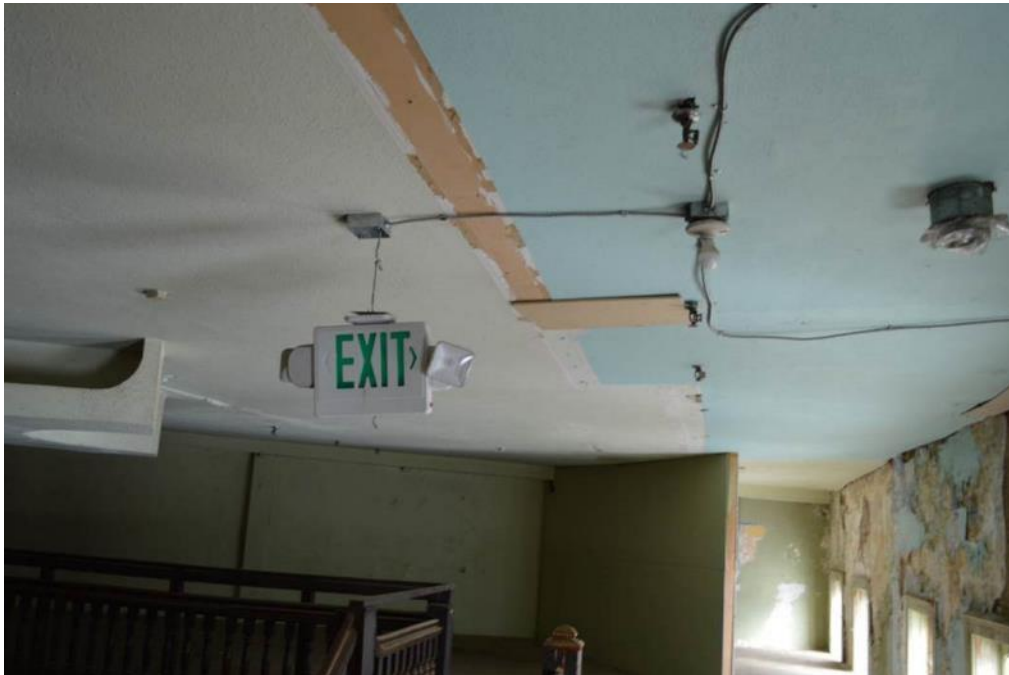
*Figure 162: Detail view of ceiling above the mezzanine.*

- Remove mold from the gypsum board in the main theatre space. (Critical)
- Patch gypsum board ceiling above the mezzanine including in the men's and women's restrooms and the storage room. Prep, prime, and paint the ceiling to attain a uniform appearance. (Minor)

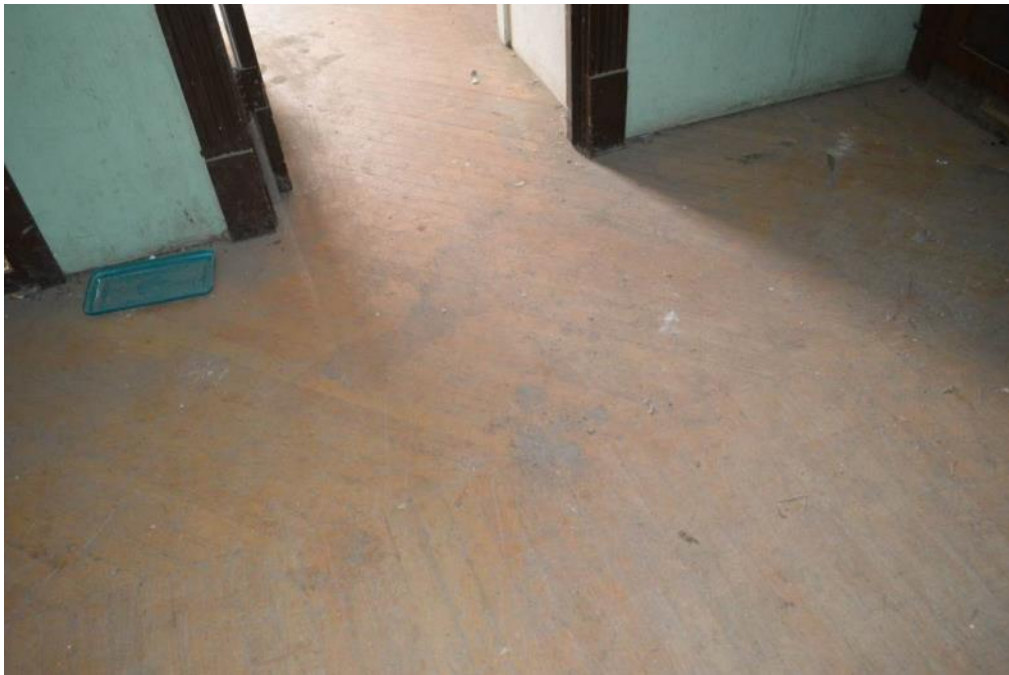
Throughout the theatre, the flooring is tongue and groove wood flooring. The boards measure approximately 2 ¼ inches wide. This flooring may have been installed when the building was in use as a gymnasium (*Re: Figure 166*). At the bottom of the stairs to the mezzanine there is red carpet which was installed at an unknown date (*Re: Figure 167*). This carpet continues up the stair.

*Figure 166: Detail view of wood flooring at the east end of the theatre space. Note flooring transitions from straight laid wood flooring to diagonal wood flooring.*

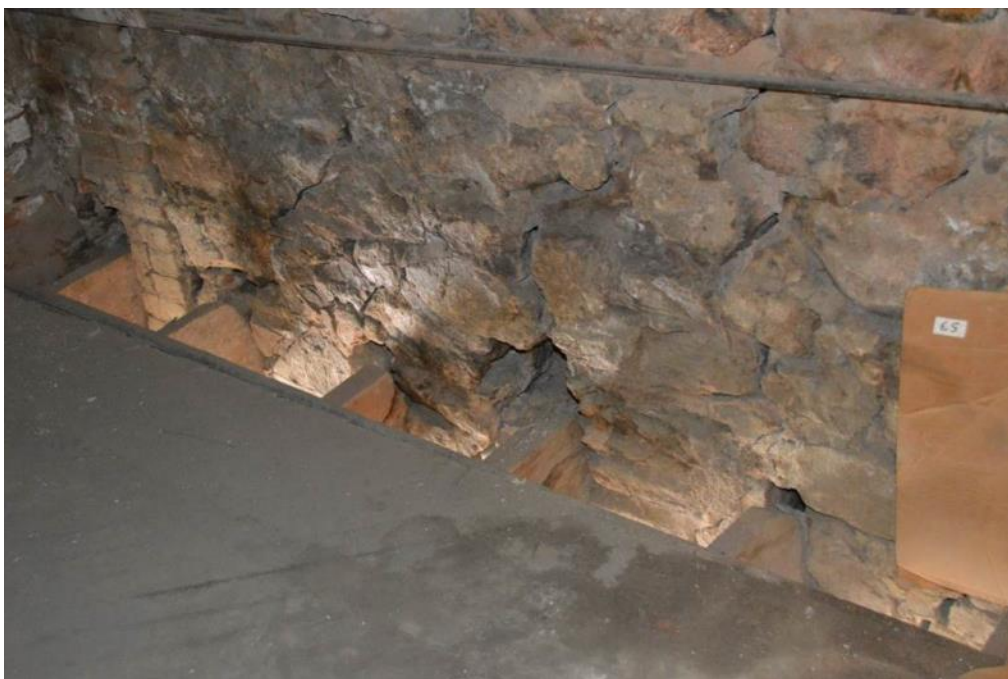
The men's room has medium stained wood flooring laid diagonally. The women's room has similar flooring. In the women's room, the diagonally laid flooring stops at the wood framed partition wall, where it switches to being laid straight from north to south. The diagonally laid flooring continues in the storage room at the south end of the women's room. In the storage room, the flooring stops approximately 8 inches short of the south masonry wall, leaving the joist ends exposed (*Re: Figure 168*).

*Figure 168: Exposed joist ends in the storage room adjacent to the women's restroom.*

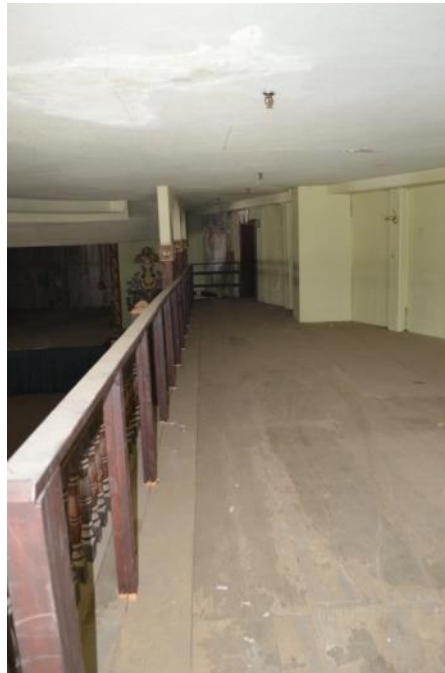
*Figure 182: Railing typical along the edge of the mezzanine.*

- Remove the secondary railing along the mezzanine. Modify the railing to meet code requirements for height. (Minor)
- Rehabilitate mezzanine and Shoo Fly railings. Rehabilitation should include:
  - Remove extant deteriorated finishes.
  - Repair wood components where required.
  - Replace missing and damaged components.
  - Re-finish wood components.
  - Alternatively, if documentation of the historic interior appearance is located, replace railings with historically appropriate railings.

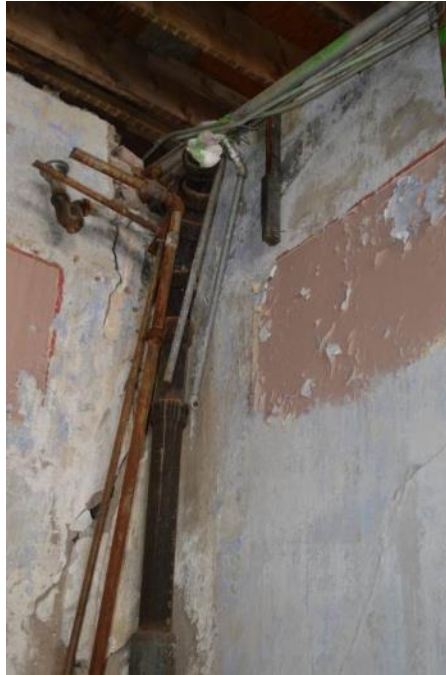
*Figure 183: Extant piping in the Shoo Fly section of the building.*

- The rehabilitation of the building will require the design and installation of a new code-compliant plumbing system. Public restrooms of the quantity required to satisfy the reuse occupancy of the building will be required. None of the existing components of the plumbing system should be assumed to be reusable. (Serious)

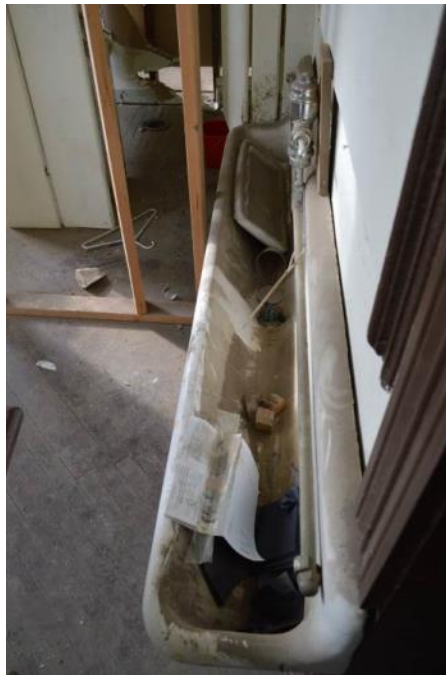
*Figure 184: Plumbing fixture extant in the men's room in the upper level of the theatre section of the building.*

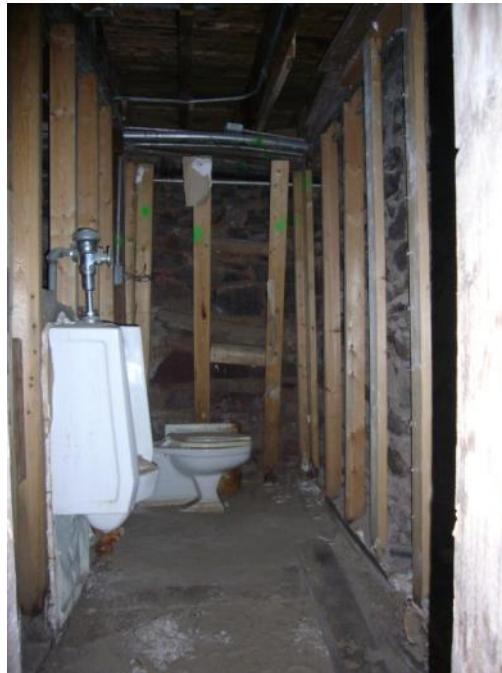
*Figure 185: Plumbing fixtures in the men's room in the lower level of the Shoo Fly.*

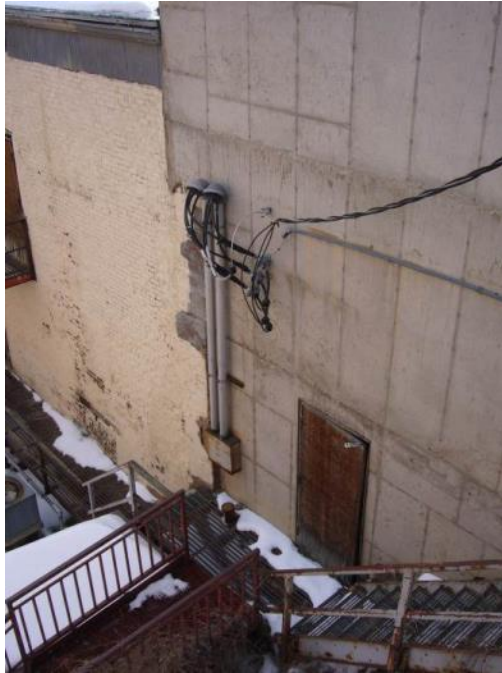
Electrical service enters the building on the north elevation, at the east end of the north wall of the fly space (Re: Figure 187). An electrical meter is located on the exterior of the north wall of the fly space on Pine Street. The main electrical panels are located on the east wall of the stage/fly space. The electrical service to the building appears to be 400 amp, 3-phase, 120/208 volt service. The electrical service panels appear to consist of several fused disconnect switches. There are two electrical panel boards. Panel A is located on the north wall of the stage/fly space. Panel A is a 225 amp, 3 phase, 42-pole electrical panel, as manufactured by Square D. The panel is protected by a 200 amp, fused disconnect switch. The second electrical panel is located on the ground floor or lower level in the "pit" area. Panel B is a 100 amp, single phase, 16-pole load center, protected by a 100 amp, fused disconnect switch. (Re: Figure 188.)

*Figure 187: Electrical service entry on the north elevation.*

- A thorough evaluation of the existing electrical service entry, distribution equipment and panelboards by a qualified electrical engineer is recommended to determine if any of these components can be reincorporated into a complete building rehabilitation. If mechanical air conditioning is required or desired, the existing 400 amp service is probably not adequate. (Critical)
- The complete replacement of the electrical service with new equipment is recommended as part of a complete building rehabilitation. (Serious)

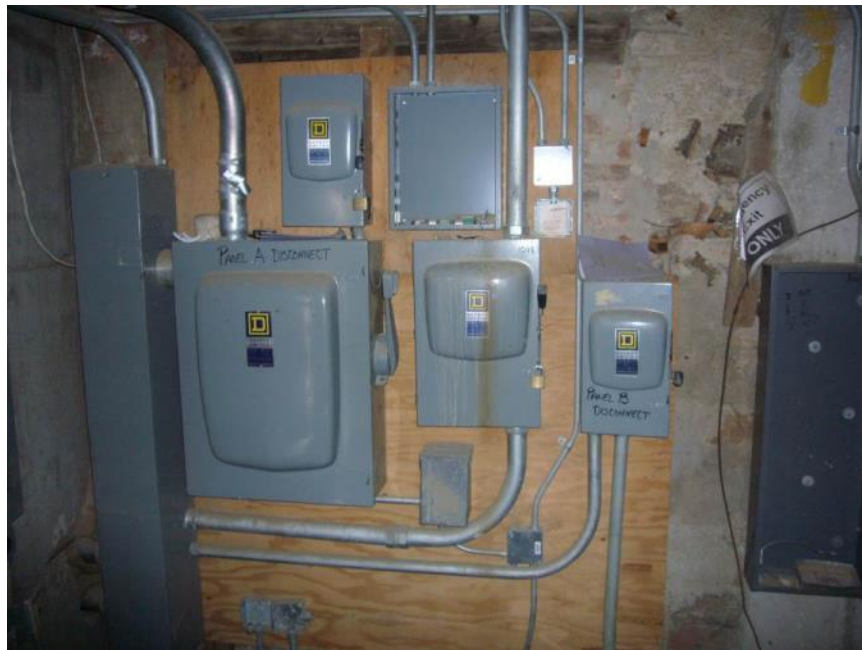
*Figure 188: Main electrical service and disconnects.*

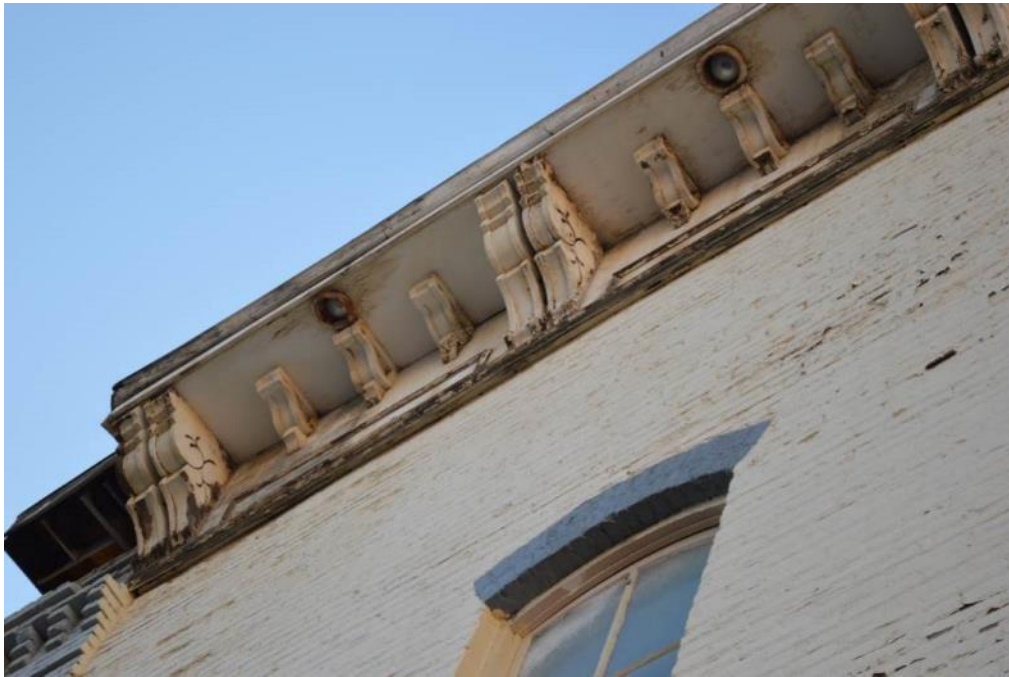
Along the east elevation there are eight recessed light fixtures in the wood cornice along the north section of the building (*Re: Figure 189*). At the south entrance in the north section of the building there is conduit visible above the door opening (*Re: Figure 190*). There is no extant light fixture in this location, but presumably there was a light fixture in this location previously. The dates of installation of the light fixtures throughout the building are unknown.

*Figure 189: Exterior lights along the east elevation cornice.*

- Install historically appropriate exterior light fixtures at building entrances and elsewhere as appropriate. Fixtures should be simple in design and should not detract from the historic character of the building or damage any extant original finishes. (Serious)

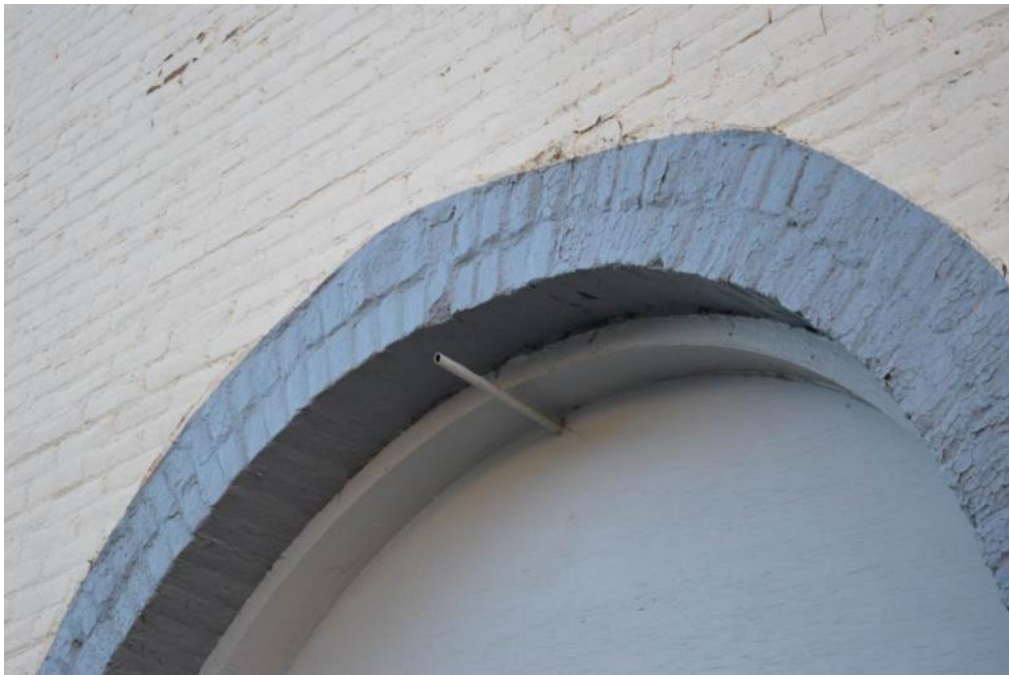
*Figure 190: Conduit above exterior door opening, indicating location of a previous light fixture.*

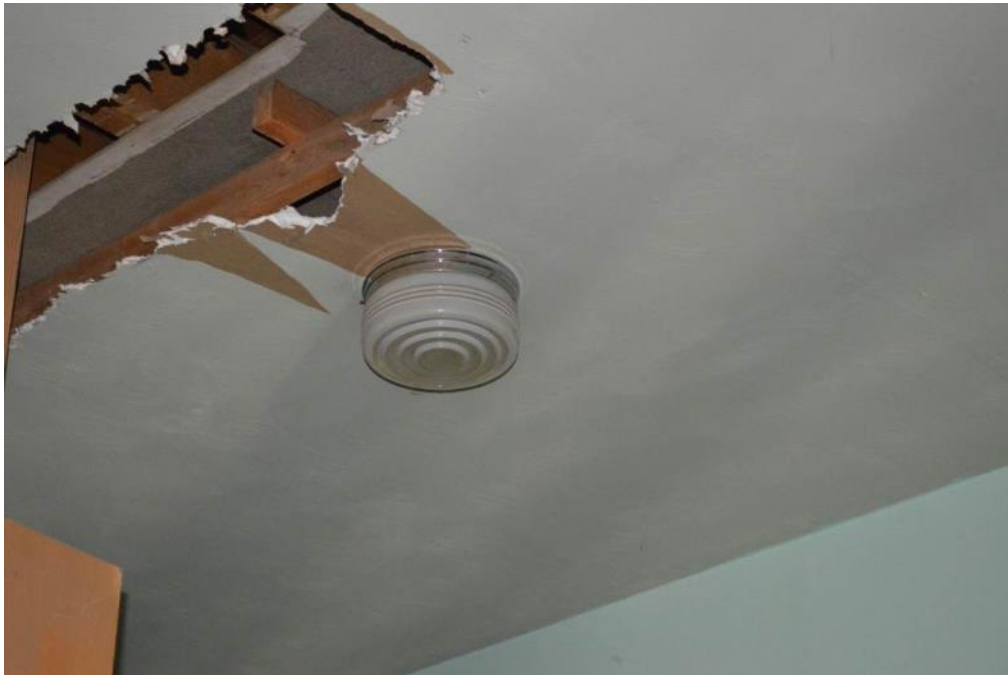
Only a few areas in the building have extant interior light fixtures. The fixtures that do exist are in poor to fair condition. (Re: Figure 191, Figure 192, and Figure 193.) Exit light fixtures and emergency egress lighting were also observed. (Re: Figure 194.)

The existing lighting fixtures are in poor condition. Most areas of the building do not have light fixtures. Fixtures that do exist are damaged, partially installed or in poor to fair condition.

*Figure 191: Ceiling mounted light fixture in the lower level of the theatre section of the building.*

- A complete redesign of the interior lighting is recommended as part of the rehabilitation of the building. New lighting should be chosen to accommodate the new uses of the building, for energy efficiency and for compatibility with the historic character of the building. (Serious)
- Preservation Brief 18: Rehabilitating Interiors in Historic Buildings: Identifying and Preserving Character-Defining Elements should be used to guide the selection of new lighting fixtures.

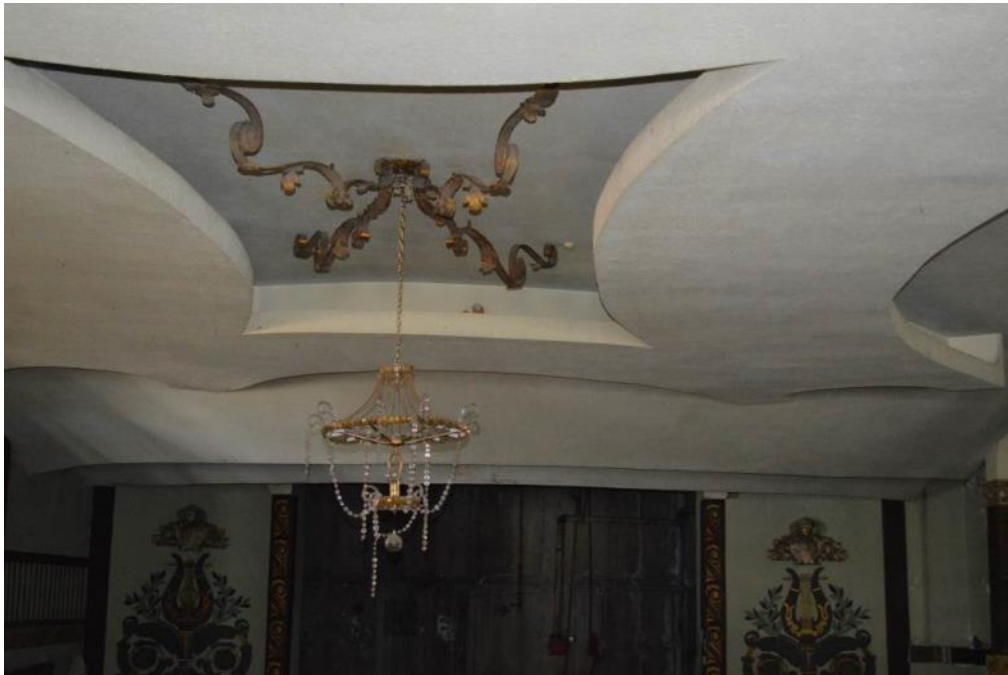
*Figure 192: Ceiling mounted chandelier in the theatre space.*

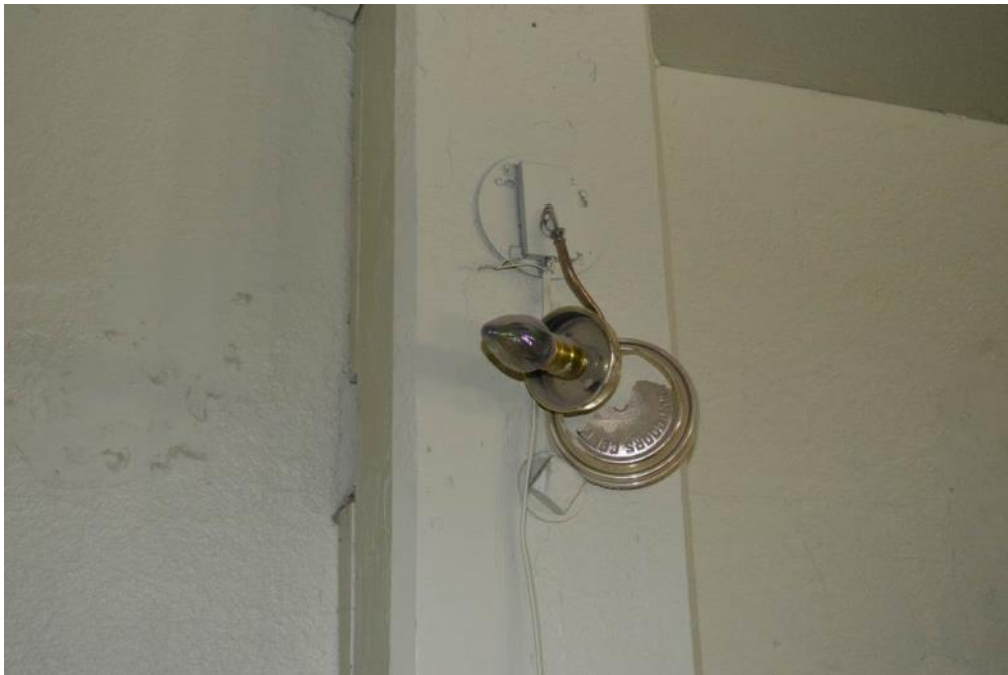
*Figure 193: Wall sconce on the north wall of the mezzanine.*

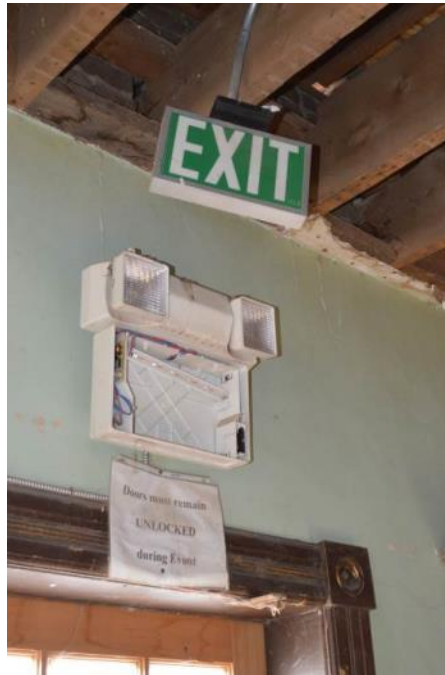
*Figure 194: Illuminated exit sign and emergency light fixture above the south door from the Shoo Fly.*

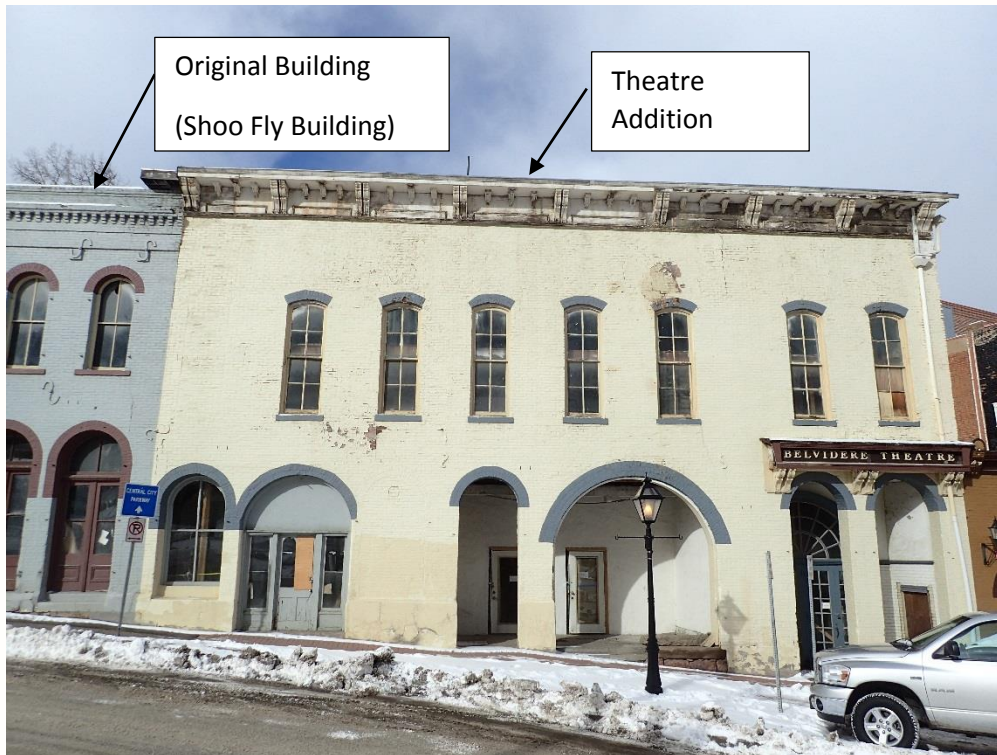
Figure 1: Overview of Belvidere Theatre East elevation

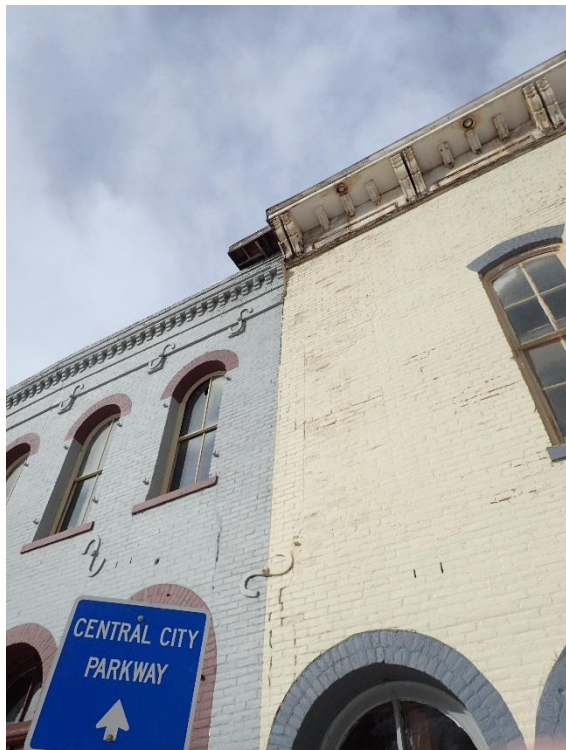
We observed the tie rod and perpendicular masonry wall at the second floor level nearest to the Shoo Fly building (Figures 2 and 3). There is a large diagonal crack located within the second floor wall (Figure 3). The tie rod bridges this crack. There are significant structural cracks in this same wall at the lower floor level (Figures 4 through 6). These cracks include sheared header bricks at the corners (Figures 5) and a vertical separation which indicates the façade is moving independently of the perpendicular wall (Figure 6). Originally these two walls were connected by the now fractured header bricks.

Figure 2: S-shaped anchor plate (Note multiple plates at original building, but single plate at addition façade)

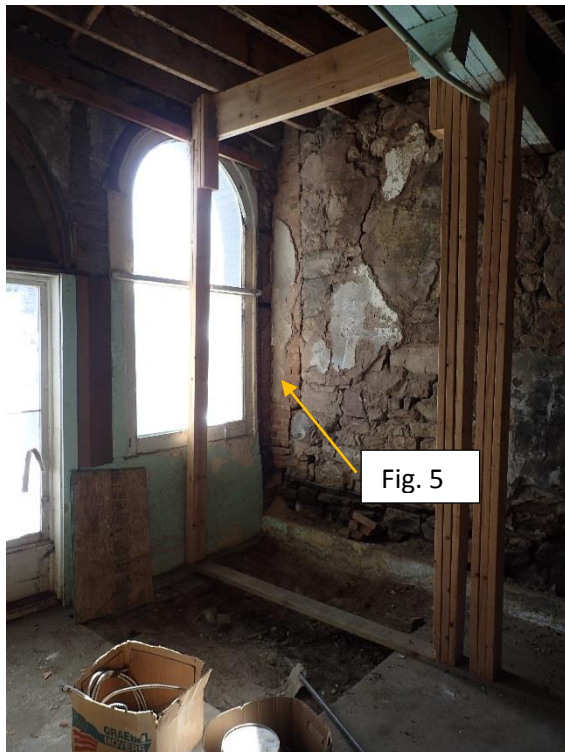
Figure 4: Overview view of wall below tie-rod location

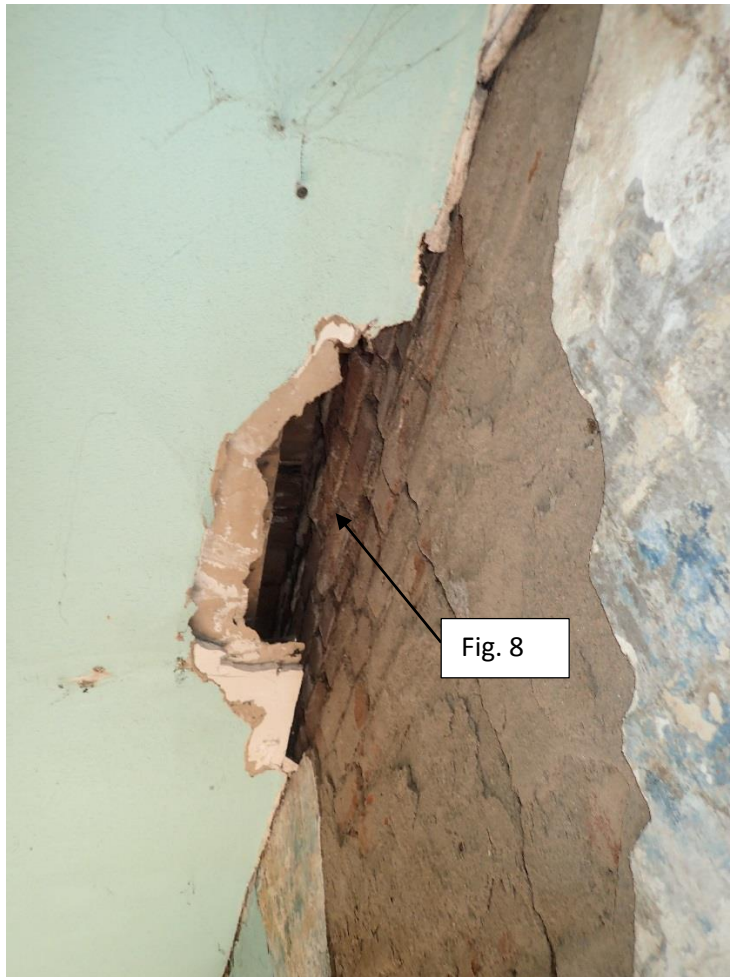
The second floor and attic floor wood framing structure runs parallel to the façade. We observed at an existing opening in the second floor ceiling that there is a board pocketed into the inside face of the façade (Figure 7). There is a vertical crack at this location (Figure 8). We also noted vertical cracks in the entry way that have occurred since the last time the façade was painted (Figures 9 to 11).

Figure 7: Attic floor to wall interface overview opening in ceiling
